LUCAS ELECTRICAL STATOR OR ROTOR INSTALL GUIDANCE

**PLEASE READ THESE IMPORTANT INSTRUCTIONS BEFORE
INSTALLING YOUR NEW LUCAS STATOR OR ROTOR.**

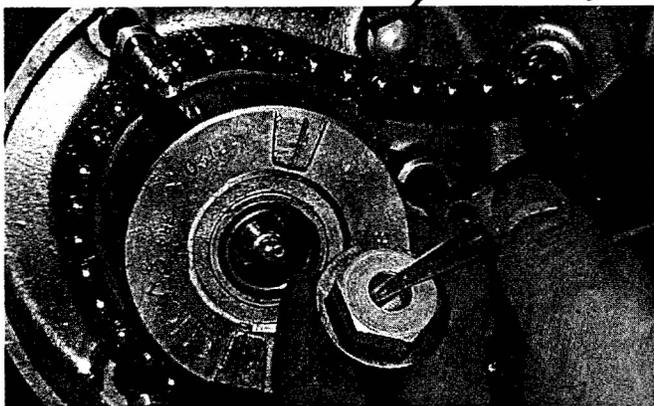
After the locating key is offered and rotor slid on the crankshaft put a couple of drops of low strength loctite on the nut. Notice that the tab washer is on the nut. Be sure the "tit" on the tab engages the rotor key groove in the stator (some bike use a serrated lock washer).

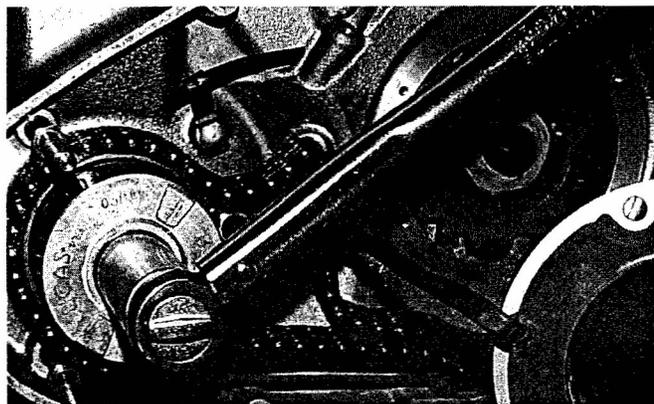
Torque the rotor nut. Triumph's use 30 foot pounds while Norton recommends 70 to 80 foot pounds. Check with your workshop manual.

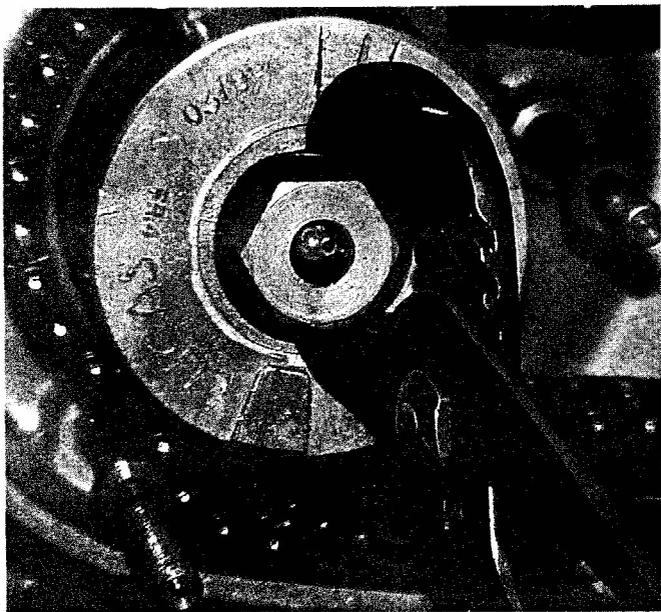
Start bending the tab washer with a screw driver. Finish it with a pair of water pump pliers.

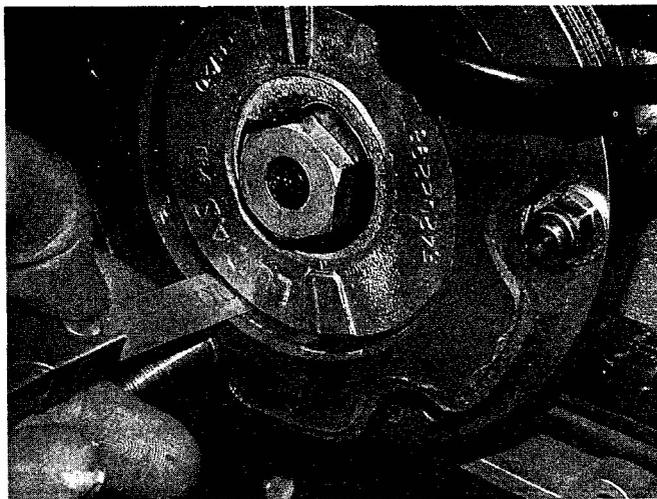
After offering and securing the stator check the rotor to stator clearance Insert a .008" feeler gauge between the rotor and the stator and slide it around checking all 360 degrees.

If you read your manual it will tell you that .008" clearance is need for all to work properly. Less, and the natural flexing of the crankshaft can cause the face rotor to rub on the steel plates of the stator. If this happens the heat generated can roast the insulation on the stator and melt the metal holding the rotor together.

Now as stated in the Norton Workshop Manual: "Check the gap between the stator and rotor which must give a minimum air gap of 0.008" to 0.010". Any misalignment of the stator mounting studs would account for the reduced air gap at any one point and can only be corrected by very careful slight realignment of the studs."

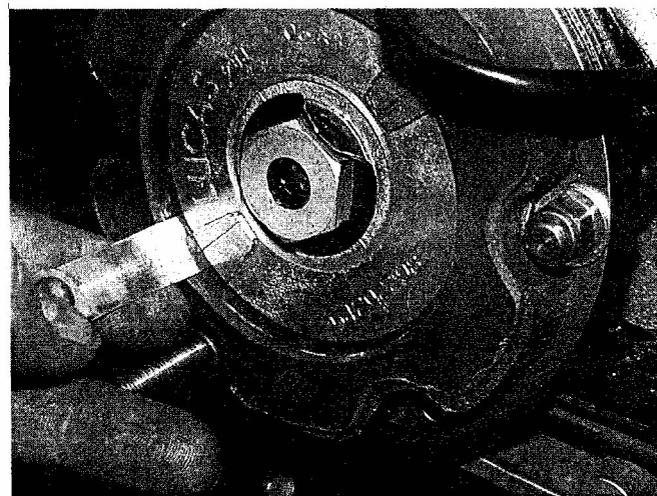
Because the mainshaft the rotor is mounted on could be bent rotate the rotor 60 degrees and check the clearance again. Do this each 60 degrees until you are back to where you started. If there is less than .008" clearance it must be corrected before the bike is used. Normal crank flexure can cause the rotor to hit the stator if there is less than .008" clearance.

To be sure that you have checked for all possibilities you must rotate the rotor during the checking process. Turn the motor through its 360 degrees stopping every 60 degrees to check the clearance between the stator poles and the magnet. It is possible for the stator to be off center and further have the rotor mounted to a bent mainshaft (a fairly common condition). If the rotor mounted on a bent mainshaft is sitting in an offset position, which lines up with the stator's offset, you can have a false impression that the rotor has the required .008" clearance. In this condition when you rotate the motor 180 degrees the offset rotor can run right up against the stator on the other side or have less than the required clearance.

Few mechanics skip the warning to check the air gap, but many don't realize that it is just as important to rotate the rotor in 60° steps and do the checking six times. The stub holding the rotor could have been bent over the years. You start where you installed the rotor and with a .008" feeler gauge go around the rotor 360° confirming the clearance. Then turn the motor 60° and repeat. Do this until you are back to where you started.
