Please read these important instructions before opening your new Sparx Stator or Rotor

INSTALLING THE STATOR AND ROTOR

Sparx Three PHASE Alternator Kit

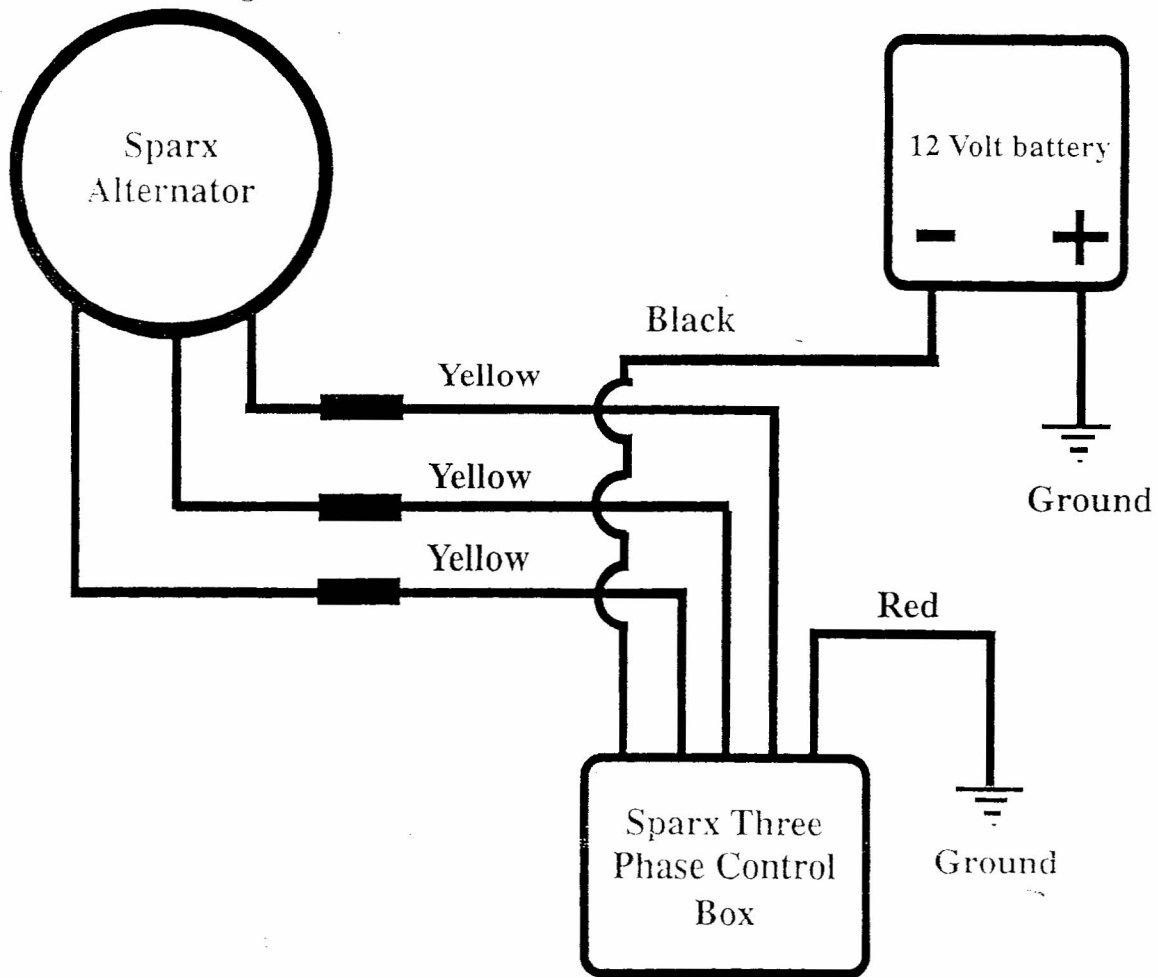
wired POSITIVE ground

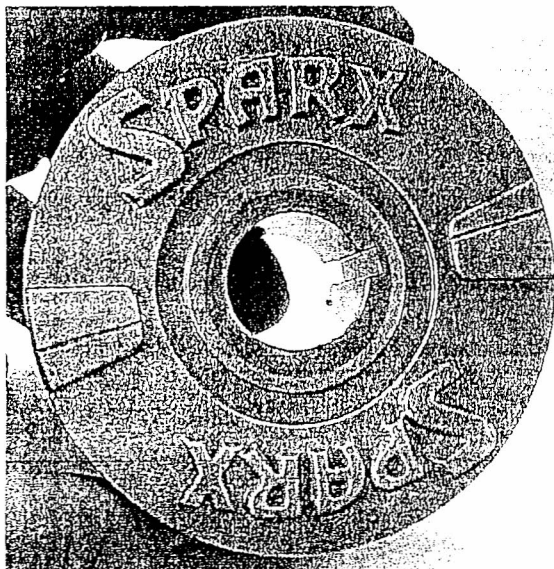
For Triumph, BSA , and Triumph twins and Singles mount the rotor with Sparx logo facing you. Timing mark is Full Advance or 38 degrees BTDC.

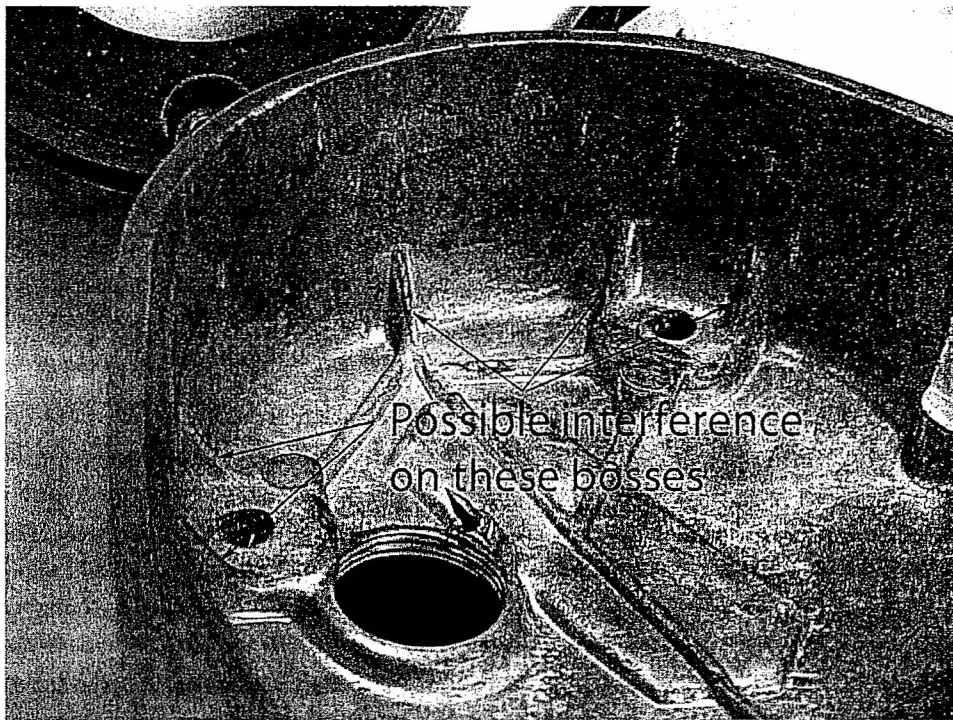
Due to manufacturing tolerances, and the increase size of the 3 phase stator, some Triumph T140s can have some interference between the Sparx stator and the primary cover. If present, the primary cover is held away from the engine cases by the thickness of a primary gasket. Careful removal of a little material on the primary cover's inner bosses (shown in photo) will cure the problem.
